MECKLENBURG COUNTY
DEPARTMENT OF ENVIRONMENTAL HEALTH

SOIL INVESTIGATION REPORT

SITE INVESTIGATION REPORT
INDIVIDUAL SEPTIC TANK SYSTEM
WITH SUBSURFACE,
SOIL ABSORPTION,
EFFLUENT DISCHARGE

SIP NO. 12504
T.C. NO. 025-105-23,22
MAP DATE 2-21-75

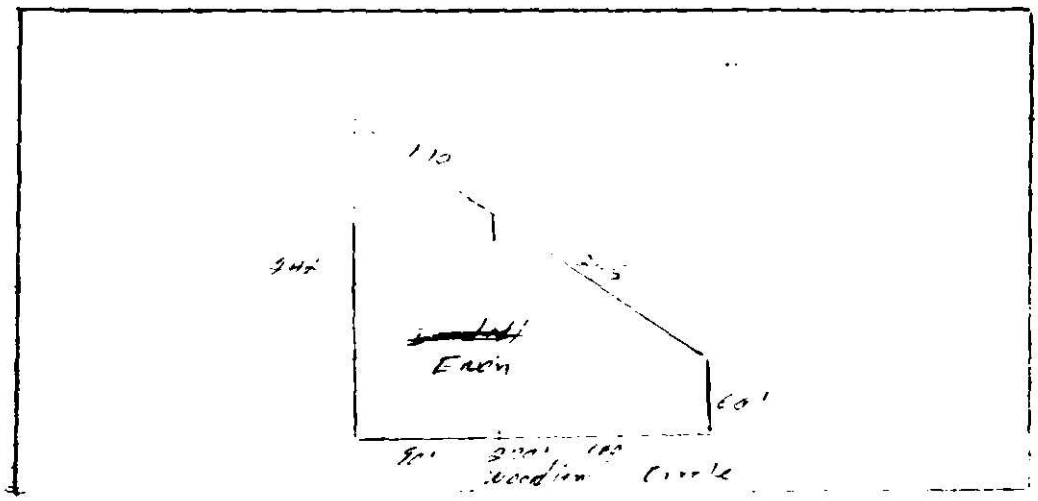
DIAGRAM OF PROPERTY

Recommendations Soil & Site investigation of lot was found suitable for installation of a septic tank system.
