APPLICATION FOR SOIL INVESTIGATION

APPENDIX H
SITE EVALUATION

SITE INVESTIGATION REPORT
INDIVIDUAL SEPTIC TANK SYSTEM
WITH SUBSURFACE,
SOIL ABSORPTION,
EFFLUENT DISCHARGE

LOCATION OF LOT Goldsmith Lane, Lot 43

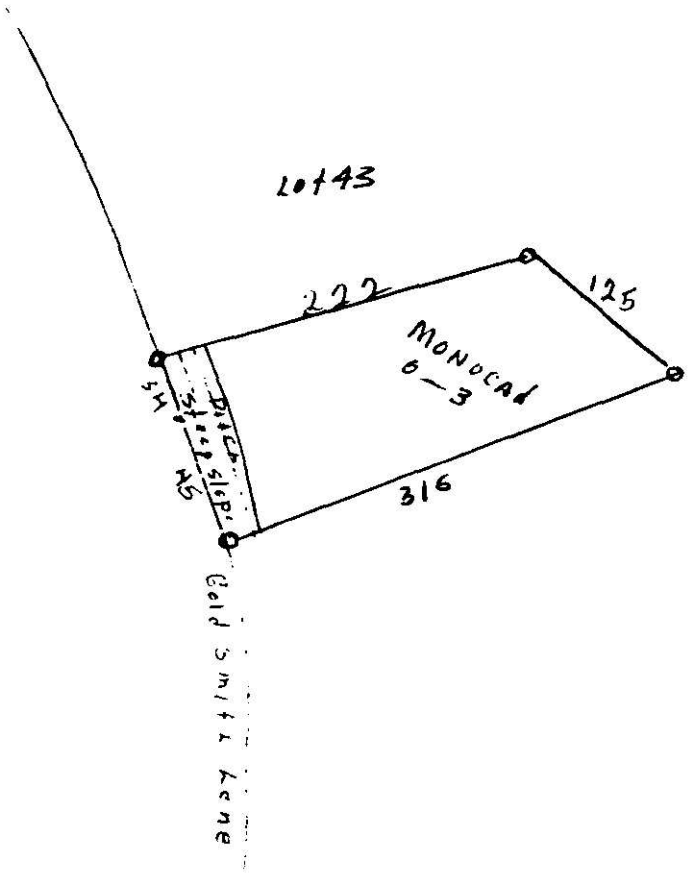
FACTORS	AREA 1	AREA 2	AREA 3	AREA 4
1. SLOPE (%)	S PS 0-3 (U)	S PS U	S PS U	S PS U +
2. SOIL TEXTURE (12-36 in.) (Sandy, loamy, clayey, Note 2:1, Clay)	S (PS) Loamy U	S PS U	S PS U	S PS U
3. SOIL STRUCTURE (12.36 in.) (Clayey Soils)	S Weak (PS) Blocky U	S PS U	S PS U	S PS U
4. SOIL DEPTH (In.)	S PS >48 (U)	S PS U	S PS U	S PS U
5. RESTRICTIVE HORIZONS (In.) (Impervious Strata, Rock)	S (PS) None U	S PS U	S PS U	S PS U
6. SOIL DRAINAGE/GROUNDWATER (External & Internal)	S Slow PS (U) Flood Plain	S PS U	S PS U	S PS U
7. SOIL PERMEABILITY (Percolation Rate)	S PS (U) Slow	S PS U	S PS U	S PS U
8. OTHER (Specify)	S PS U	S PS U	S PS U	S PS U
9. SITE CLASSIFICATION	Unsuitable			
SOIL SERIES	MONOCAN

Lot 43
222
125
MONOCAD
6—3
316
Gold Smith Lane
