# MECKLENBURG COUNTY
# DEPARTMENT OF ENVIRONMENTAL HEALTH

## APPLICATION FOR SOIL INVESTIGATION

APPENDIX H
SITE EVALUATION

SITE INVESTIGATION REPORT
INDIVIDUAL SEPTIC TANK SYSTEM
WITH SUBSURFACE,
SOIL ABSORPTION,
EFFLUENT DISCHARGE

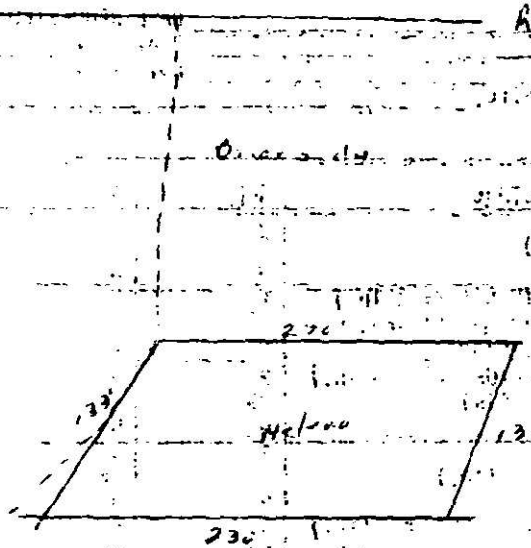
| FACTORS | AREA 1 | AREA 2 | AREA 3 | AREA 4 |
|---|---|---|---|---|
| 9. SITE CLASSIFICATION | unsuitable | | | |
| SOIL SERIES | Helena | | | |

Soil Structure Massive

Perched Water Table

Soil Permeability Unsuitable

Site Classification Unsuitable
