APPLICATION FOR SOIL INVESTIGATION

SOIL INVESTIGATION REPORT

SITE INVESTIGATION REPORT
INDIVIDUAL SEPTIC TANK SYSTEM
WITH SUBSURFACE,
SOIL ABSORPTION,
EFFLUENT DISCHARGE

LOCATION OF LOT Brief Road, Lot 12, BLock 223

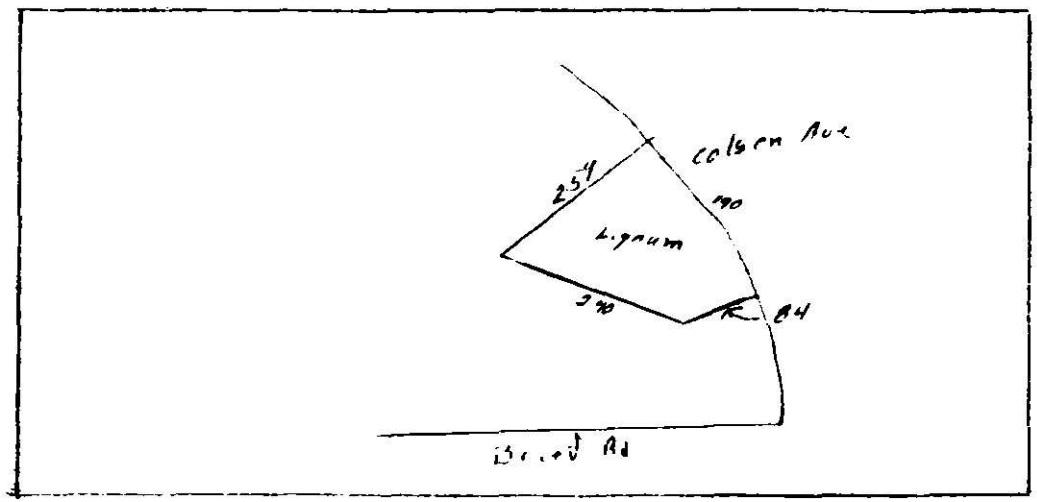
DIAGRAM OF PROPERTY

Soil Properties	Soil 1	Soil 2	Soil 3	Soil 4
1. Soil Series	Lenham			
2. Soil Slope	Suitable 2 to 6			
3. Soil Depth	Unsuitable 2 36"			
4. Soil Texture	Unsuitable 2-1 Expanding Clay			
5. Soil Structure	Unsuitable [redacted] Clay			
6. Restrictive Horizons				
7. Soil Drainage	Suitable 2 6' To water Table			
8. Soil Permeability (Percolation Rate)				
9. Other				
10. Overall Rating	Unsuitable 1 Slow 77 minutes

Remarks.
Recommendations Based on this investigation, the soils on the lot were found to be unsuitable for the installation of a septic tank system
