MECKLENBURG COUNTY HEALTH DEPARTMENT

APPLICATION FOR PERCOLATION TEST

SITE INVESTIGATION REPORT
INDIVIDUAL SEPTIC TANK SYSTEM
WITH SUBSURFACE,
SOIL ABSORPTION,
EFFLUENT DISCHARGE

APPENDIX H
SITE EVALUATION

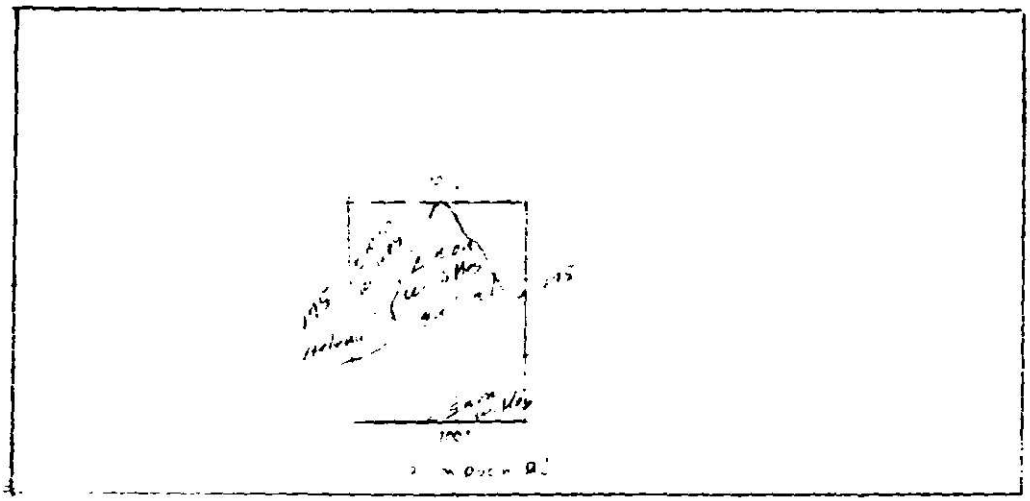
DIAGRAM OF PROPERTY

The lot described above is not recommended for the installation of an individual septic tank system with subsurface, soil absorption, effluent discharge due to the following:

Soil Permeability Unsuitable.

Percolation rate in excess of 200 min/in.

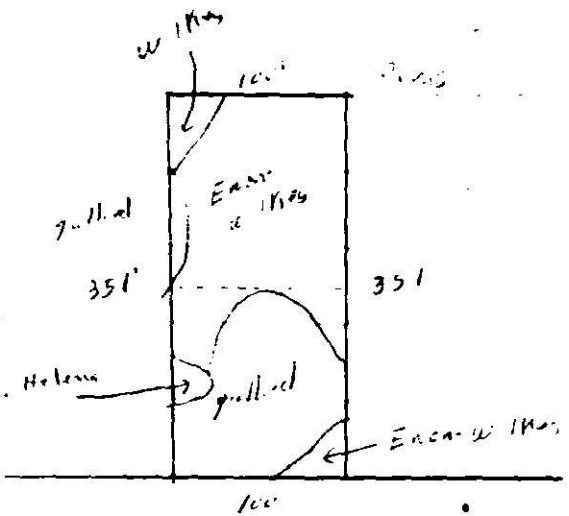
* See Diagram on Back (Include: Soil areas, property lines, roads, streams, gullies, wet areas, fill areas, wells, water bodies, slope patterns)

FACTORS	AREA 1	AREA 2	AREA 3	AREA 4
1. SLOPE (%)	S 2+2% PS U	S 2+2% PS U	S 2-4 PS U	S Complex PS Slopes U
2. SOIL TEXTURE (12-36 in.) (Sandy, loamy, clayey, Note 2:1, Clay)	S 2-1 PS Clay U	S 2-1 PS Clay U	S 2-1 PS Clay U	S 2-1 PS Clay U

3. SOIL STRUCTURE (12-36 in.) (Clayey Soils)	S Massive PS U	S Massive PS U	S Massive PS U	S Massive PS U
4. SOIL DEPTH (In.)	S 48" PS U	S 48" PS U	S 36" PS U	S Depth Variable PS U

5. RESTRICTIVE HORIZONS (In.) (Impervious Strata, Rock)	S None PS U	S None PS U	S None PS U	S None PS U
6. SOIL DRAINAGE/GROUNDWATER (External & Internal)	S Seasonal PS Perched water U Table	S Seasonal PS Perched water U Table	S Seasonal PS Perched water U Table	S Eroded Areas PS Act As U Drainage Ways

7. SOIL PERMEABILITY (Percolation Rate)	S Slow PS U Slow	S Slow PS U Slow	S Slow PS U Slow	S Slow PS U Slow
8. OTHER (Specify)	S PS U	S PS U	S PS U	S PS U

9. SITE CLASSIFICATION	Unsuitable	Unsuitable	Unsuitable	Unsuitable
SOIL SERIES	Helena	Enon w/ Iredell	Iredell	Enon w/ Iredell Eroded

w Ikns
100'
Encr w Ikns
351'
351
Helena
gvll.rd
Encr w Ikns
100'
Simpson Rd
