MECKLENBURG COUNTY HEALTH DEPARTMENT

APPLICATION FOR PERCOLATION TEST

SOIL INVESTIGATION REPORT

SOIL EVALUATION REPORT
INDIVIDUAL SEPTIC TANK SYSTEM
WITH SUBSURFACE,
[illegible]
EFFLUENT DISCHARGE

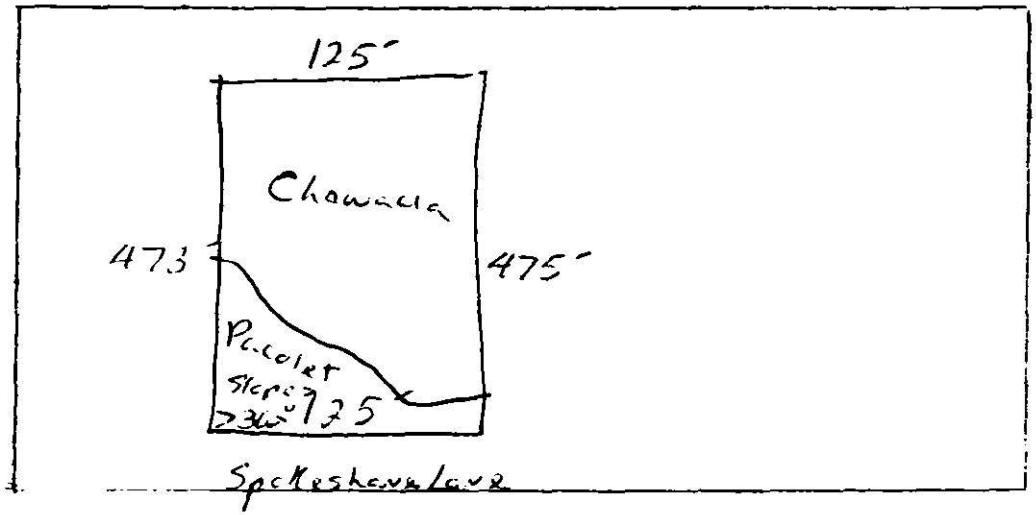
DIAGRAM OF PROPERTY

Soil Properties	Soil 1	Soil 2	Soil 3	Soil 4
1. Soil Series	Chewelah		Pacific	
2. Soil Slope	—		unsuitable >30%	
3. Soil Depth	—		unsuitable <48"	
4. Soil Texture	—		provisionally suitable clay	
5. Soil Structure	—		provisionally suitable blocky	
6. Restrictive Horizons	—		—	
7. Soil Drainage	unsuitable poorly drained		suitable water table >6'	
8. Soil Permeability (Percolation Rate)	unsuitable seasonal high water table & slow		provisionally suitable moderate	
9. Other	unsuitable surface flooding		Comm/ind inadequate area	
10. Overall Rating	unsuitable		provisionally unsuitable

Recommendations Based on this investigation, the soils were found to be unsuitable for installation of a septic tank system.

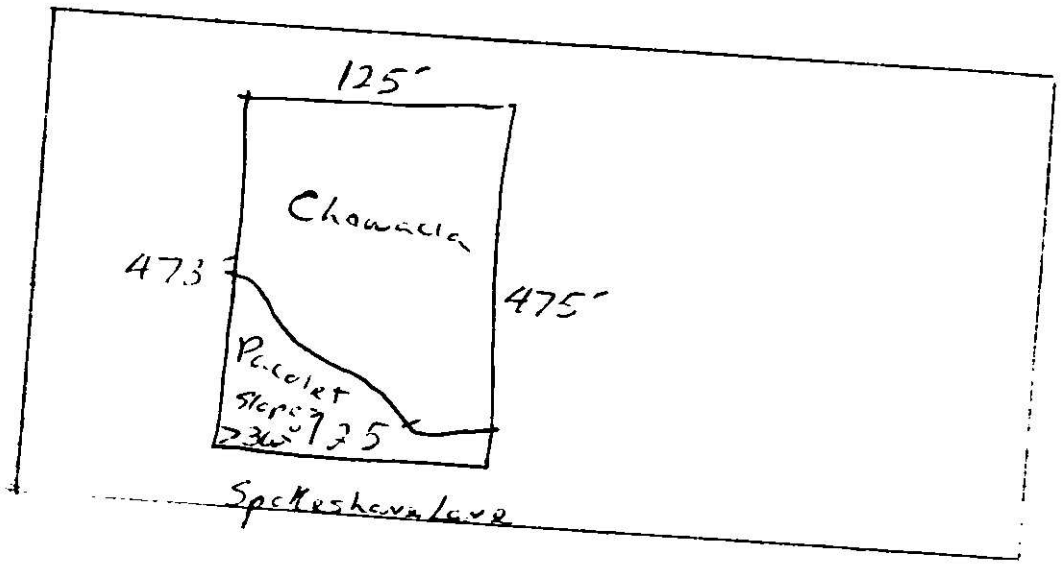
DIAGRAM OF PROPERTY

Soil Properties	Soil 1	Soil 2	Soil 3	Soil 4
1. Soil Series	Chewelah		Pacific	
2. Soil Slope	—		unsuitable >30%	
3. Soil Depth	—		unsuitable <48"	
4. Soil Texture	—		provisionally suitable clay	
5. Soil Structure	—		provisionally suitable blocky	
6. Restrictive Horizons	—		—	
7. Soil Drainage	unsuitable poorly drained		suitable water table >6'	
8. Soil Permeability (Percolation Rate)	unsuitable seasonal high water table 6" from		provisionally suitable moderate	
9. Other	unsuitable surface Floods		60 min/in unsuitable rock	
10. Overall Rating	provisionally Suitable		provisionally unsuitable

Recommendations Based on this investigation, the soils were found to be unsuitable for installation of a septic tank system.
