APPLICATION FOR SOIL INVESTIGATION

APPENDIX II
SITE EVALUATION

SITE INVESTIGATION REPORT
INDIVIDUAL SEPTIC TANK SYSTEM
WITH SUBSURFACE,
SOIL ABSORPTION,
EFFLUENT DISCHARGE

LOCATION OF LOT Hammond Drive, Lot 34

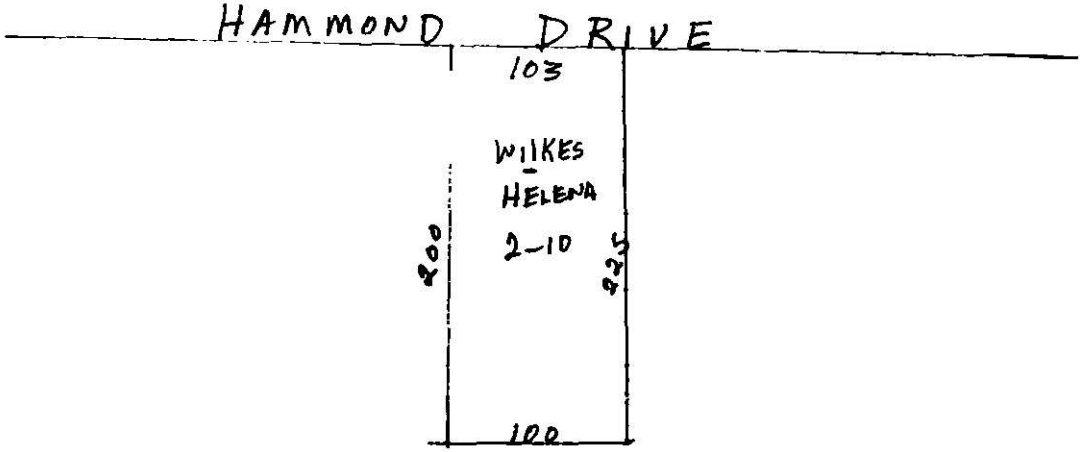
LOT 34

FACTORS		AREA 1	AREA 2	AREA 3	AREA 4
1. SLOPE (%)	S / (PS) / U	2-10	PS	PS	PS
2. SOIL TEXTURE (12-36 in.) (Sandy, loamy, clayey, Note 2-1. Clay)	S / (PS) / (U)	2-1 Clay Mixed	PS	PS	PS
3. SOIL STRUCTURE (12.36 in.) (Clayey Soils)	S / PS / (U)	Massive	PS	PS	PS
4. SOIL DEPTH (In.)	S / PS / (U)	<48	PS	PS	PS
5. RESTRICTIVE HORIZONS (In.) (Impervious Strata, Rock)	S / PS / (U)	Clays	PS	PS	PS
6. SOIL DRAINAGE/GROUNDWATER (External & internal)	S / PS / (U)	Slow	PS	PS	PS
7. SOIL PERMEABILITY (Percolation Rate)	S / PS / (U)	Slow	PS	PS	PS
8. OTHER (Specify)	S / PS / U		PS	PS	PS
9. SITE CLASSIFICATION		Unsuitable			
SOIL SERIES		WILKES HELENA

As determined under the Rules and Regulations promulgated by the Commission for Health Services, Division of Health Services, North Carolina Department of Human Resources, Raleigh, North Carolina, the soils on the lot described above were found to be unsuitable for the installation of an individual septic tank - soil absorption system, due to the following reason:

Soil Structure Massive

Soil Permeability Unsuitable
