SITE INVESTIGATION REPORT
INDIVIDUAL SEPTIC TANK SYSTEM
WITH SUBSURFACE,
SOIL ABSORPTION,
EFFLUENT DISCHARGE

NAME OF OWNER Mr. Paul A. Vogler

LOCATION OF LOT Highway 74, East Lot 3

APPENDIX H
SITE EVALUATION

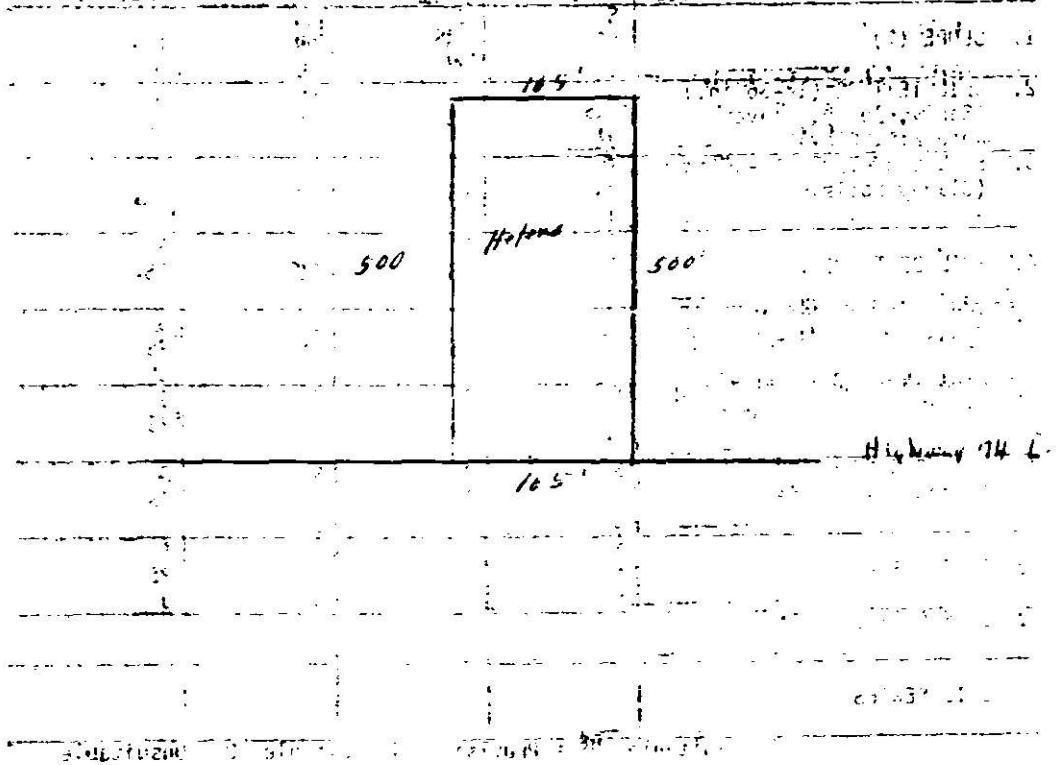
FACTORS	AREA 1	AREA 2	AREA 3	AREA 4
1. SLOPE (%)	(S) PS 2-6% U	S PS U	S PS U	S PS U
2. SOIL TEXTURE (12-36 in.) (Sandy, loamy, clayey, Note 2:1, Clay)	S PS 2:1 Clay (U)	S PS U	S PS U	S PS U
3. SOIL STRUCTURE (12-36 in.) (Clayey Soils) ✓	(S) Massive PS U	S PS U	S PS U	S PS U
4. SOIL DEPTH (In.)	(S) PS 40" U	S PS U	S PS U	S PS U
5. RESTRICTIVE HORIZONS (In.) (Impervious Strata, Rock)	(S) None PS U	S PS U	S PS U	S PS U
6. SOIL DRAINAGE/GROUNDWATER (External & Internal) ✓	S Seasonal PS Perched (U) water Table	S PS U	S PS U	S PS U
7. SOIL PERMEABILITY (Percolation Rate) ✓	S PS (U) Slow	S PS U	S PS U	S PS U
8. OTHER (Specify)	S PS U	S PS U	S PS U	S PS U
9. SITE CLASSIFICATION ✓	Unsuitable			
SOIL SERIES	Helena

* See Diagram on Back (Include: Soil areas, property lines, roads, streams, gullies, wet areas, fill areas, wells, water bodies, slope patterns)

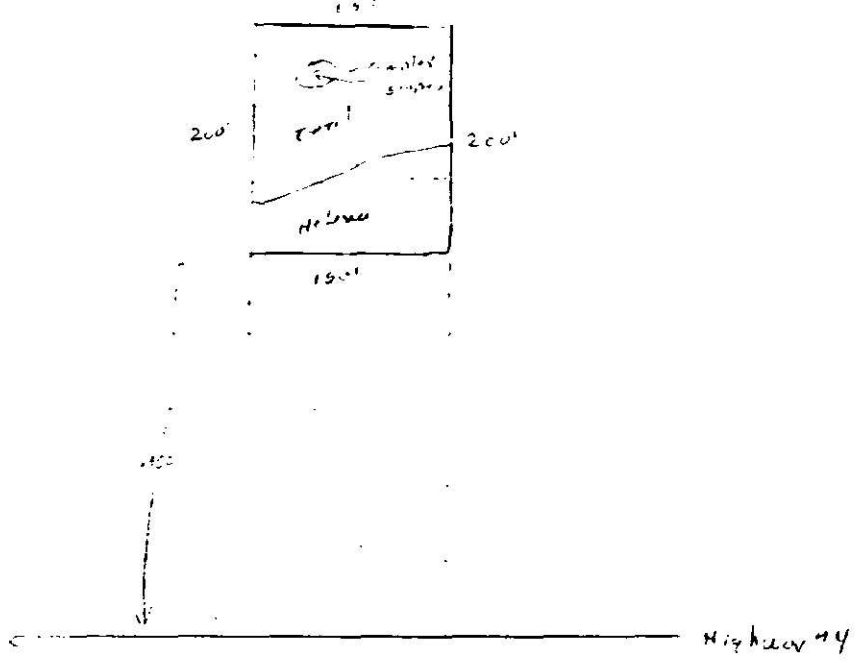
FACTORS	AREA 1	AREA 2	AREA 3	AREA 4
1. SLOPE (%)	(S) 2-6% PS U	(S) PS 2-6% U	S rolling PS slopes U	S PS U +
2. SOIL TEXTURE (12-36 in.) (Sandy, loamy, clayey, Note 2:1, Clay)	S (PS) clay U	S 2:1 PS clay U	S (PS) clay U	S PS U

3. SOIL STRUCTURE (12.36 in.) (Clayey Soils)	S (PS) Blocky U	S PS Massive U	S (PS) Blocky U	S PS U
4. SOIL DEPTH (In.)	(S) 40" PS U	(S) 40" PS U	S 12-20" PS Variable U	S PS U

5. RESTRICTIVE HORIZONS (In.) (Imprevious Strata, Rock)	(S) None PS U	(S) None PS U	S None PS U	S PS U
6. SOIL DRAINAGE/GROUNDWATER (External & Internal)	(S) 24-36" PS Grand U Water	S Seasonal PS Perched U Water Table	S Limited PS Areas, Channel U Water	S PS U

7. SOIL PERMEABILITY (Percolation Rate)	S (PS) Moderate U	S PS Slow U	S (PS) Moderate U	S PS U
8. OTHER (Specify)	S (PS) Limited Area U	S PS U	S PS U	S PS U

9. SITE CLASSIFICATION	Provisionally Suitable	Unsuitable	Prov. Suitable	
SOIL SERIES	Coxville	Johnston	Exum/Mixed Alluvial

* See Diagram on Back (Include: Soil areas, property lines, roads, streams, gullies, wet areas, fill areas, wells, water bodies, slope patterns, etc)
